Techniques for Building an OSHA Compliant Guardrail Structure

E.A. McKenzie Jr., Ph.D., P.E. and Thomas G. Bobick, Ph.D., P.E., CSP

Division of Safety Research, National Institute for Occupational Safety and Health Morgantown, WV

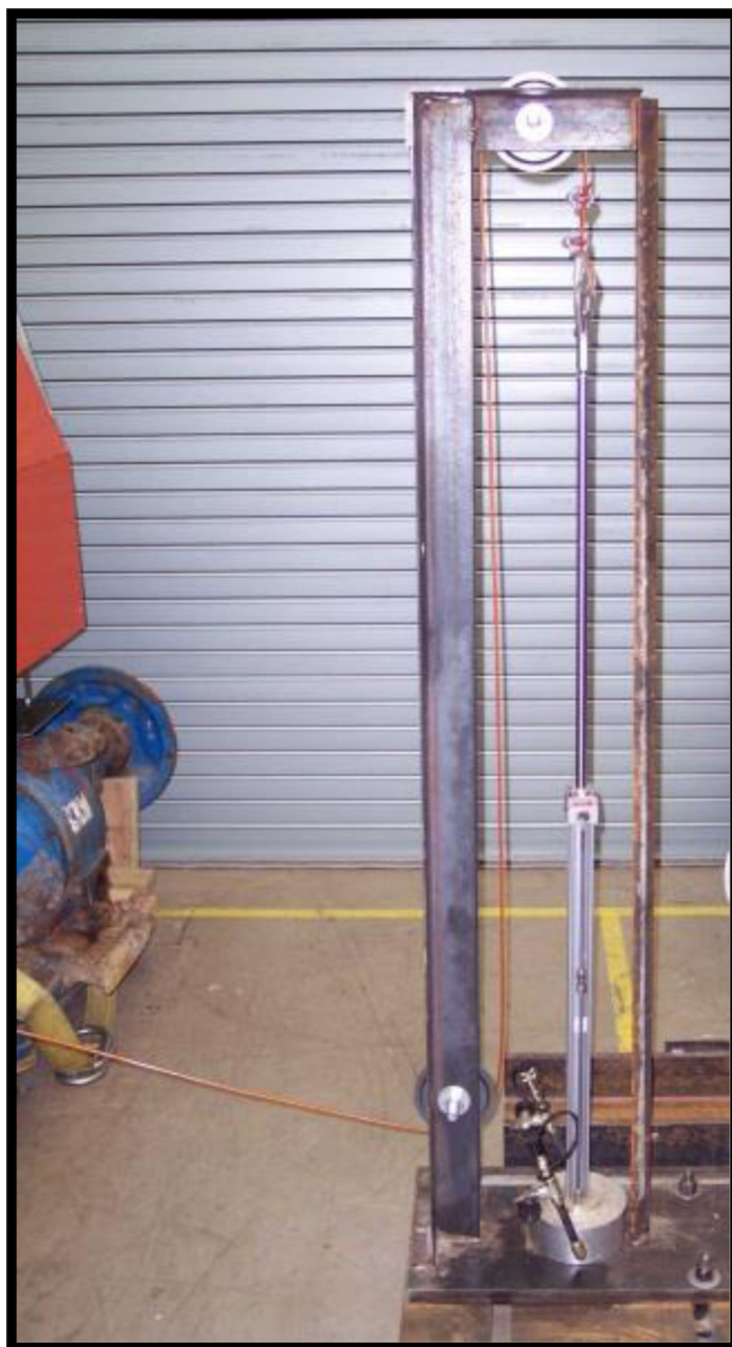
Figure 2.
PTF Testing system

The ultimate strength of each guardrail constructed was evaluated individually by using a NIOSH-developed pull-to-failure (PTF) test. The testing philosophy for this test was to quantitatively evaluate the ultimate strength of each guardrail configuration. The PTF test imposed a sustained force (lasting 2–3 seconds), which far exceeded the OSHA 200-lb falling test duration. A maximum pulling force of 800 lbs was generated using a 2-inch hydraulic cylinder, a battery-operated hydraulic pump, and a cable and pulley system as shown in Figure 2.

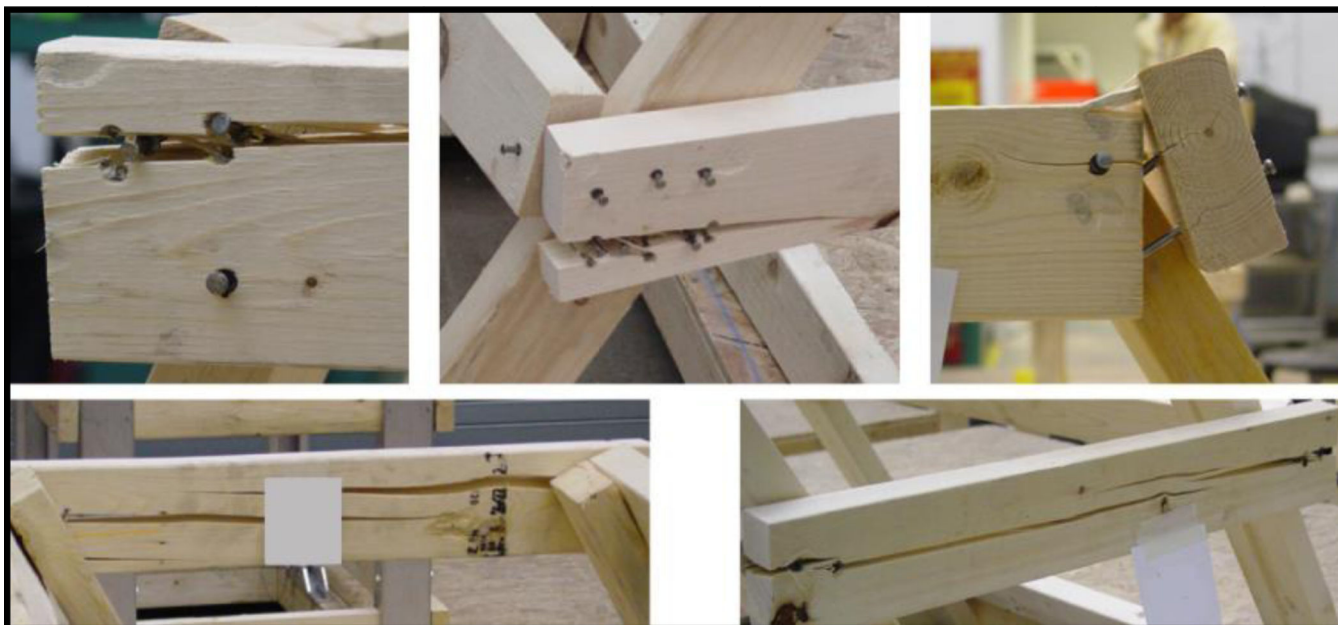
Figure 5.
Examples of Wood Splitting

Fastening the toeboard, midrail, and top rail to uprights was mostly constructed with overlapping segments. The number of fasteners used and the orientation of the boards varied. The predictability of how the midrails and top rails would react (splitting or not splitting) was dependent upon the fastener configuration. The lumber that the subjects used was construction-grade. An effort was made to select “clear lumber” for the 500 board feet of lumber used in the study. Despite being extra careful, some of the lumber had knots in them that contributed to premature failure during the pulling test. Some examples of how the wood split during the testing are shown in Figure 5.

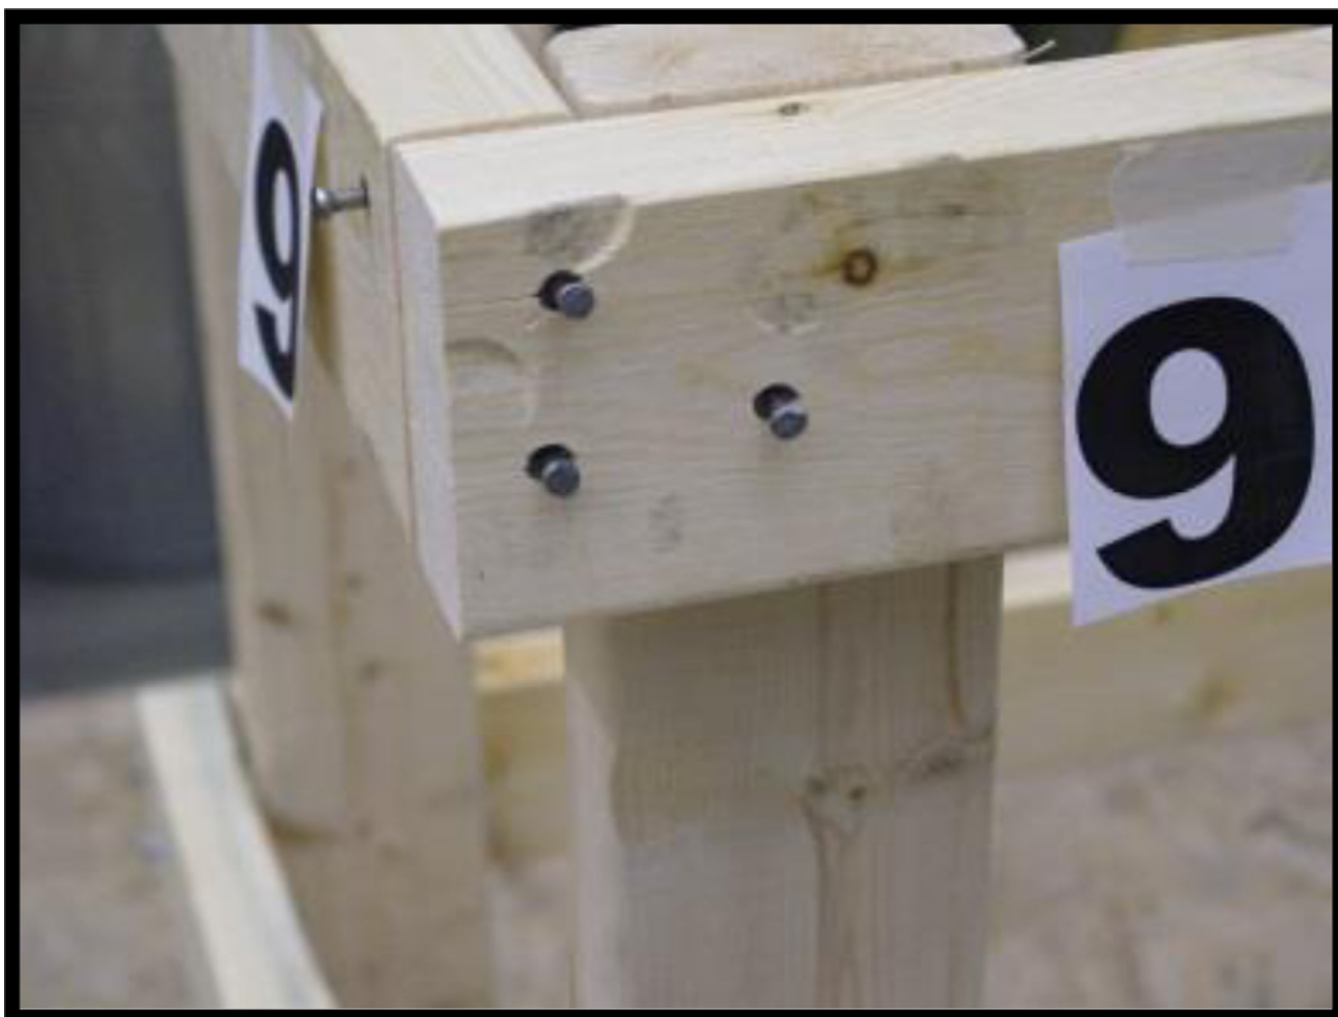
Figure 6.
Overlap Mid and Top Rails

The most critical factor identified to increase the overall strength and integrity of the guardrail structure was the construction practice of overlapping and fastening the toeboard, midrail, and top rail as shown in Figure 6. This is an example of a top rail that has been overlapped and fastened with two nails.

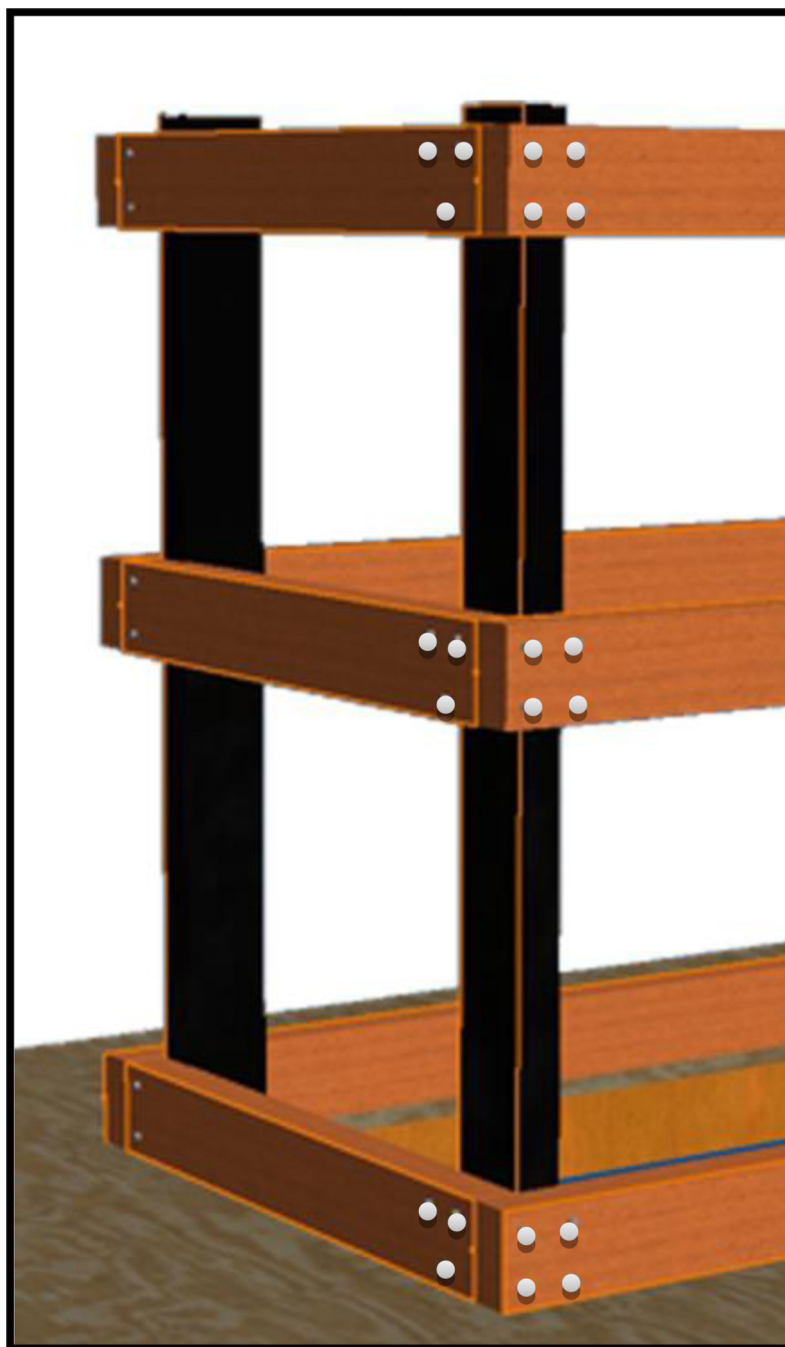
Figure 11.
Overlapped Rails and Fastener Placement

The overall strength of the structure increases when the ends of the rails overlap and are fastened to each opposing rail. The number of fasteners should be limited; more is not always better. Fasteners should be staggered if possible to prevent the wood from splitting under loading. The nail fasteners should be equally distributed into the board. When fastening into the short side of the 2"×4", two fasteners should provide acceptable strength. When fastening into the wide side of the 2"×4", three fasteners in a triangle configuration should provide acceptable strength. This is shown in Figure 11.
